DDH 205 CLASS STRUCTURAL INTEGRITY HISTORY 1951-1994

**DDH 205 CLASS
STRUCTURAL INTEGRITY HISTORY
1951-1994**

by D.J. Hussey¹, C.D. Roushorn¹, D.G. Smith², LCDR K.B. Holt³, Lt(N) K. Kirkov³

Presented at the Canadian Forces/Chief Research and Development Meeting
on "Naval Applications of Materials Technology", Halifax, May 1995.

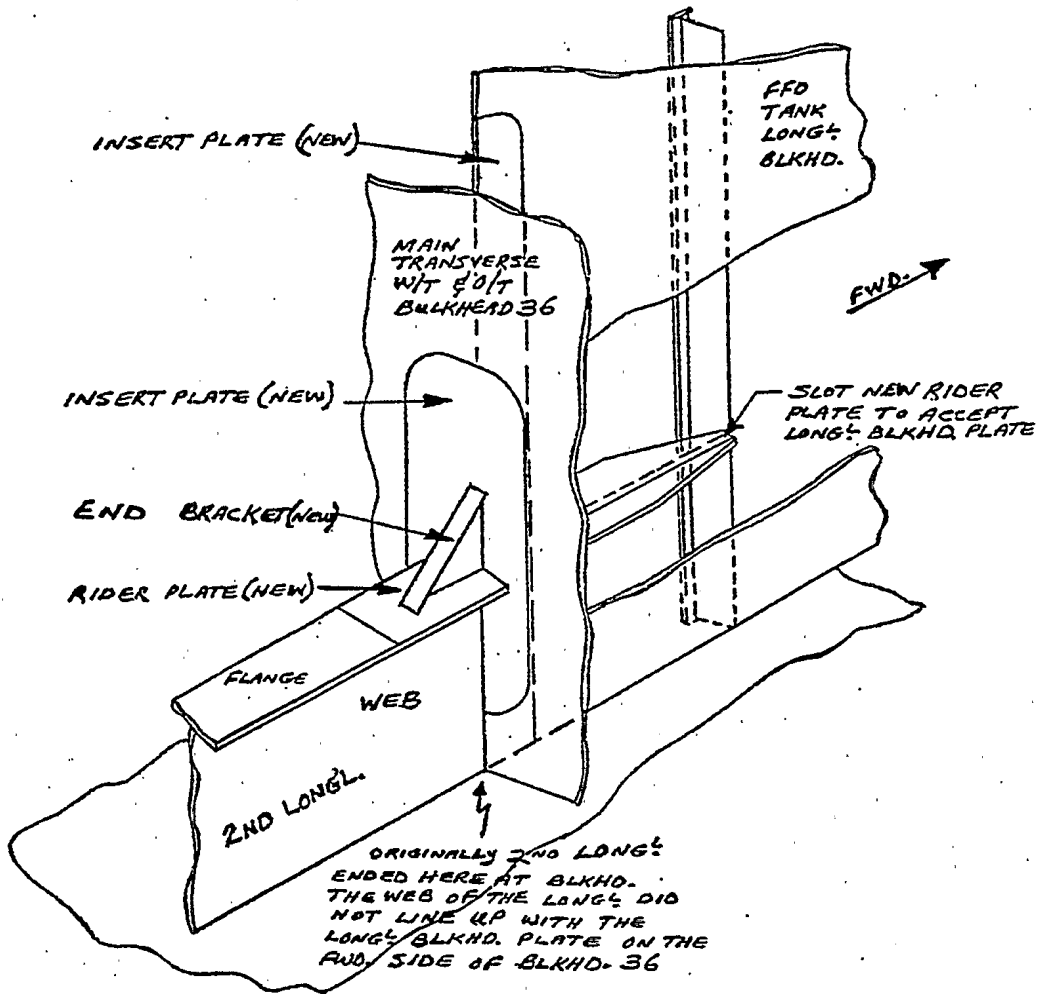
Figure 3-3

The cracking occurred at the junction of the transverse watertight bulkhead Frame Station 36, forward Boiler Room bulkhead and the longitudinal bulkheads forming the boundaries of No. 3, 4 and 5 fuel oil tanks. The cracking typifies the knife edge intersection problem and was compounded by the fact that several ships showed misalignment between the longitudinal bulkhead and the web of the longitudinal. Repairs were affected by carrying the longitudinal rider plate through the main transverse bulkhead 36 to the first vertical stiffener of the longitudinal FFO tank bulkhead, lining up the web of the longitudinal with the plate of the longitudinal FFO tank bulkhead, installing insert plates in both bulkheads (where the cracks had occurred) and fitting a beam end type bracket shown at Figure 3-3.

Junction of the Transverse Watertight Bulkhead Frame 36
Forward Boiler Room Bulkhead and the Longitudinal Bulkheads
Forming the Boundaries of No. 3, 4 and 5 Fuel Tanks

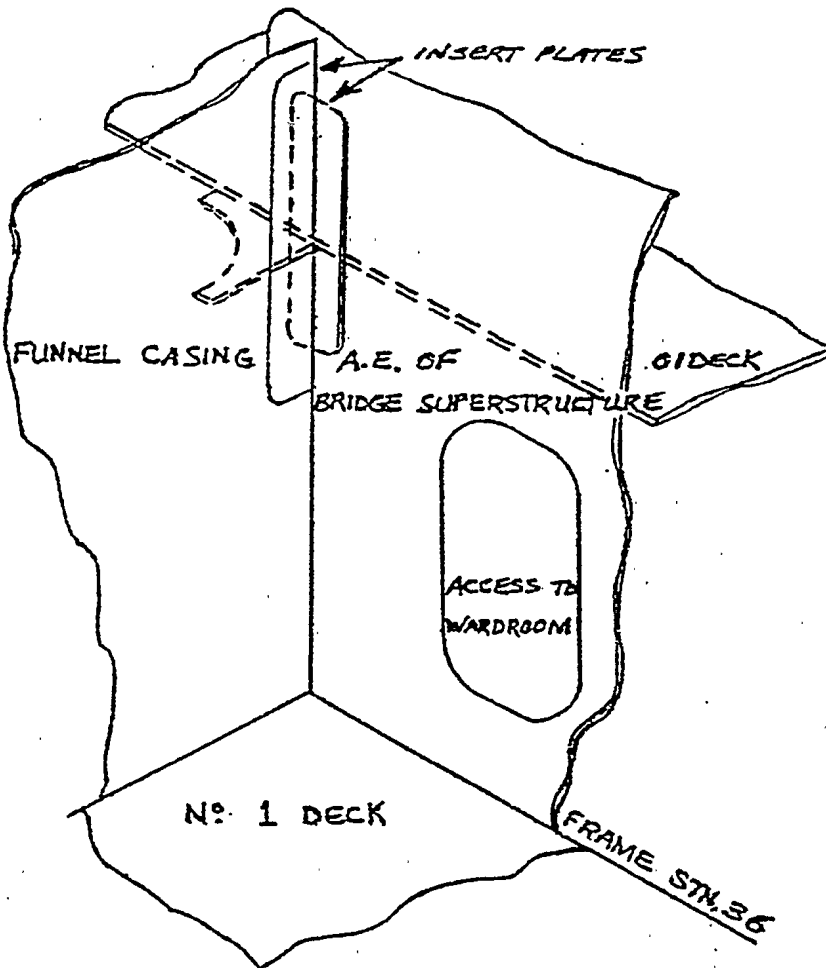
Figure 3-4

This crack occurs at the connection between the aluminum funnel casing port and starboard and the aluminum bridge structure at approximately 01 Deck level. DDH's which have rivetted superstructures have not exhibited this failure.

In welded construction a hard point exists at the location of funnel casing/01 Dk which again typifies the "knife edge intersection". Two repairs have been tried to relieve the hard spot, adding insert plates and addition of a gusset plate inside the funnel casing in line with 01 Deck.

View of Starboard After End of Bridge Superstructure
Looking Forward and Toward the Centreline

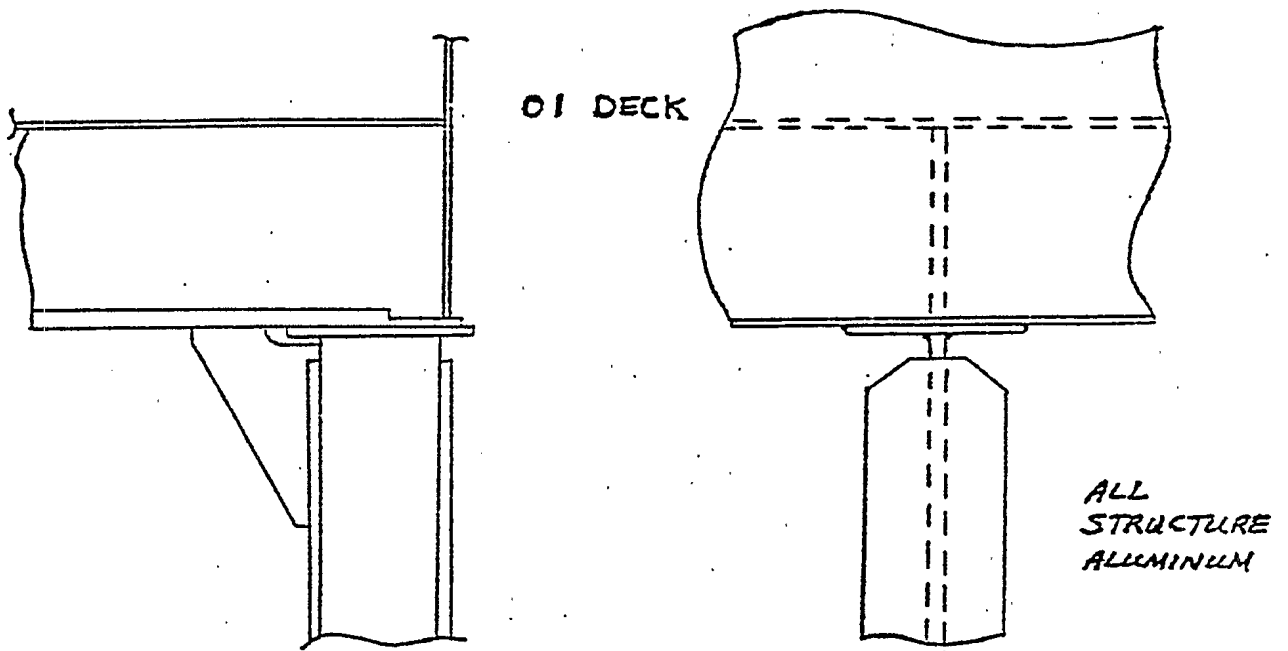
- (1) No. 1 Deck Midships Frame 41. The failure occurs at head of pillars, No. 1 Deck, which supports hangar structure. The crack results from the relative movement of the hangar deck with No. 1 Deck. In effect, the pillar is being subjected to tensile forces for which it was never designed. Two alternatives exist: strengthen the connection with the use of gusset plates or allow the hangar to move relative to the pillar. The latter has been adopted for this area because of the relatively large movement in the area. See Figure 3-5 and 3-6.

"Original" Pillar Head Arrangement
Port and Starboard Midships Frame 41

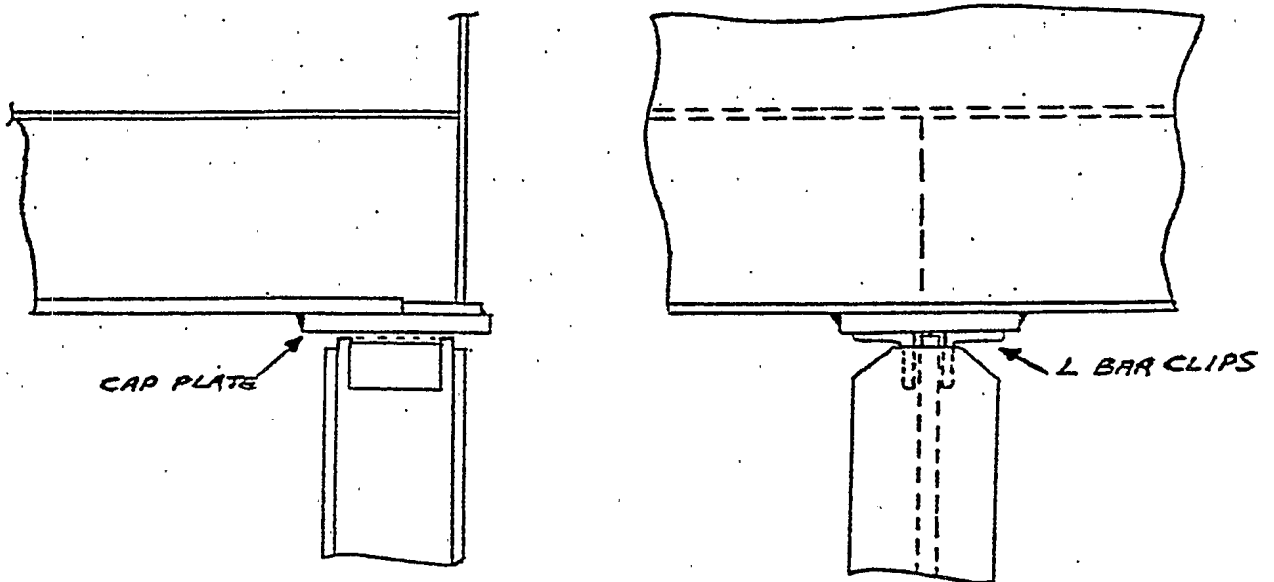
Figure 3-6

"Redesigned" Pillar Head Arrangement
Port and Starboard Midships Frame 41

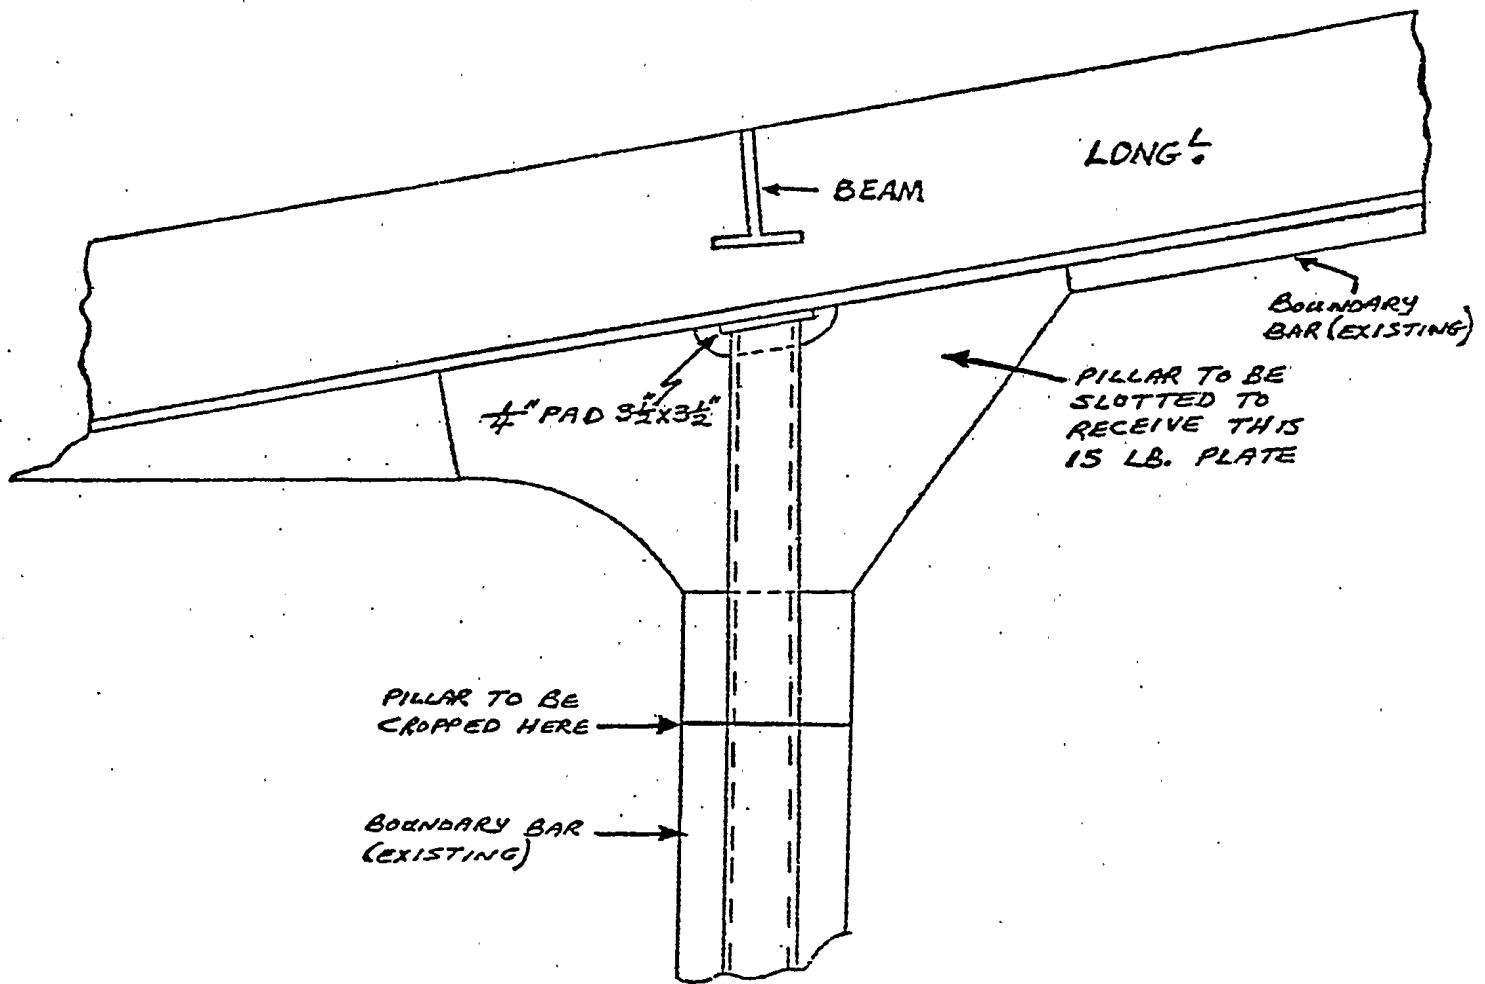
Figure 3-7

- (2) No. 3 Deck Frame 27. Three (3) in number pillars exist at Frame 27 to resist compressure loading forces between 1 Deck and 3 Deck. As stated previously, pillars are not normally designed to withstand tensile loadings of any great magnitude. In this case it was decided to restrain vertical movement between the pillar head and the 1 Deck supporting longitudinal structure to alleviate stresses from minor bulkheads which would hopefully prevent cracking and noises caused by the relative movement of minor bulkheads, boundary bars, etc. This problem was not considered so much as a structural one as it was psychological in that the cracks and noises were readily visible and audible to the ship's company. It also kept the officers awake in their cabins and created an abundance of volunteers for the morning watch!

Typical Pillar Head Connection 3 Deck Frame 27
(Modification to each Pillar is Custom Designed)

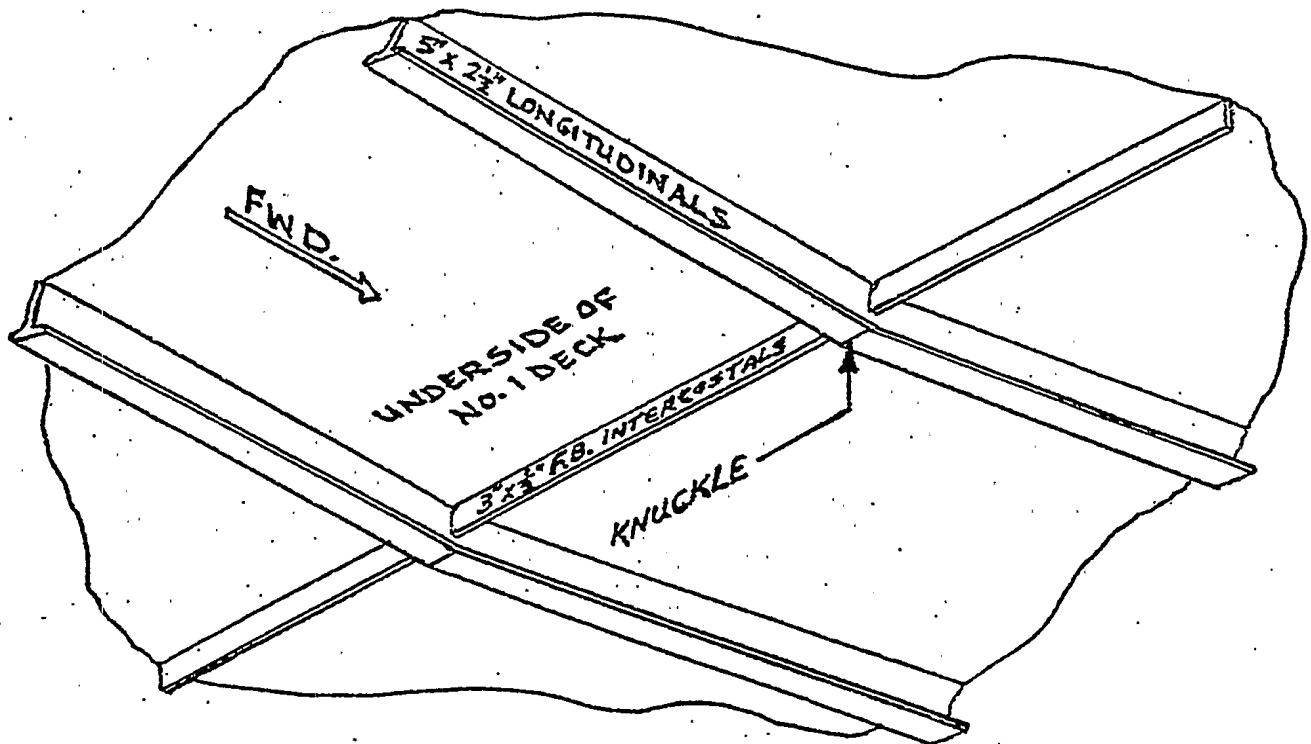
Figure 3-8

Almost all ships have experienced cracks on 1 Deck at the knuckle. The problem appears to result from the panting of the panel in a seaway with the stiffeners being too rigid because of the knuckle bend and not being able to follow the motion in a seaway. Longitudinal cracks develop along the welds of the stiffeners and by 1979 on SAGUENAY, OTTAWA, SKEENA, and MARGAREE cracks have also developed in the deck plate in way of the longitudinals. The repair is to either relieve the hard points at the knuckle by cutting slots in the longitudinals or stiffening the panels by running a flat bar across between the longitudinals. The latter to restrict panel panting has proved to be more economical. Section 5.0 uses this fracture to demonstrate the high cost of stripout, inspection, repair and replacement.

Knuckle
Frame 27 1/2

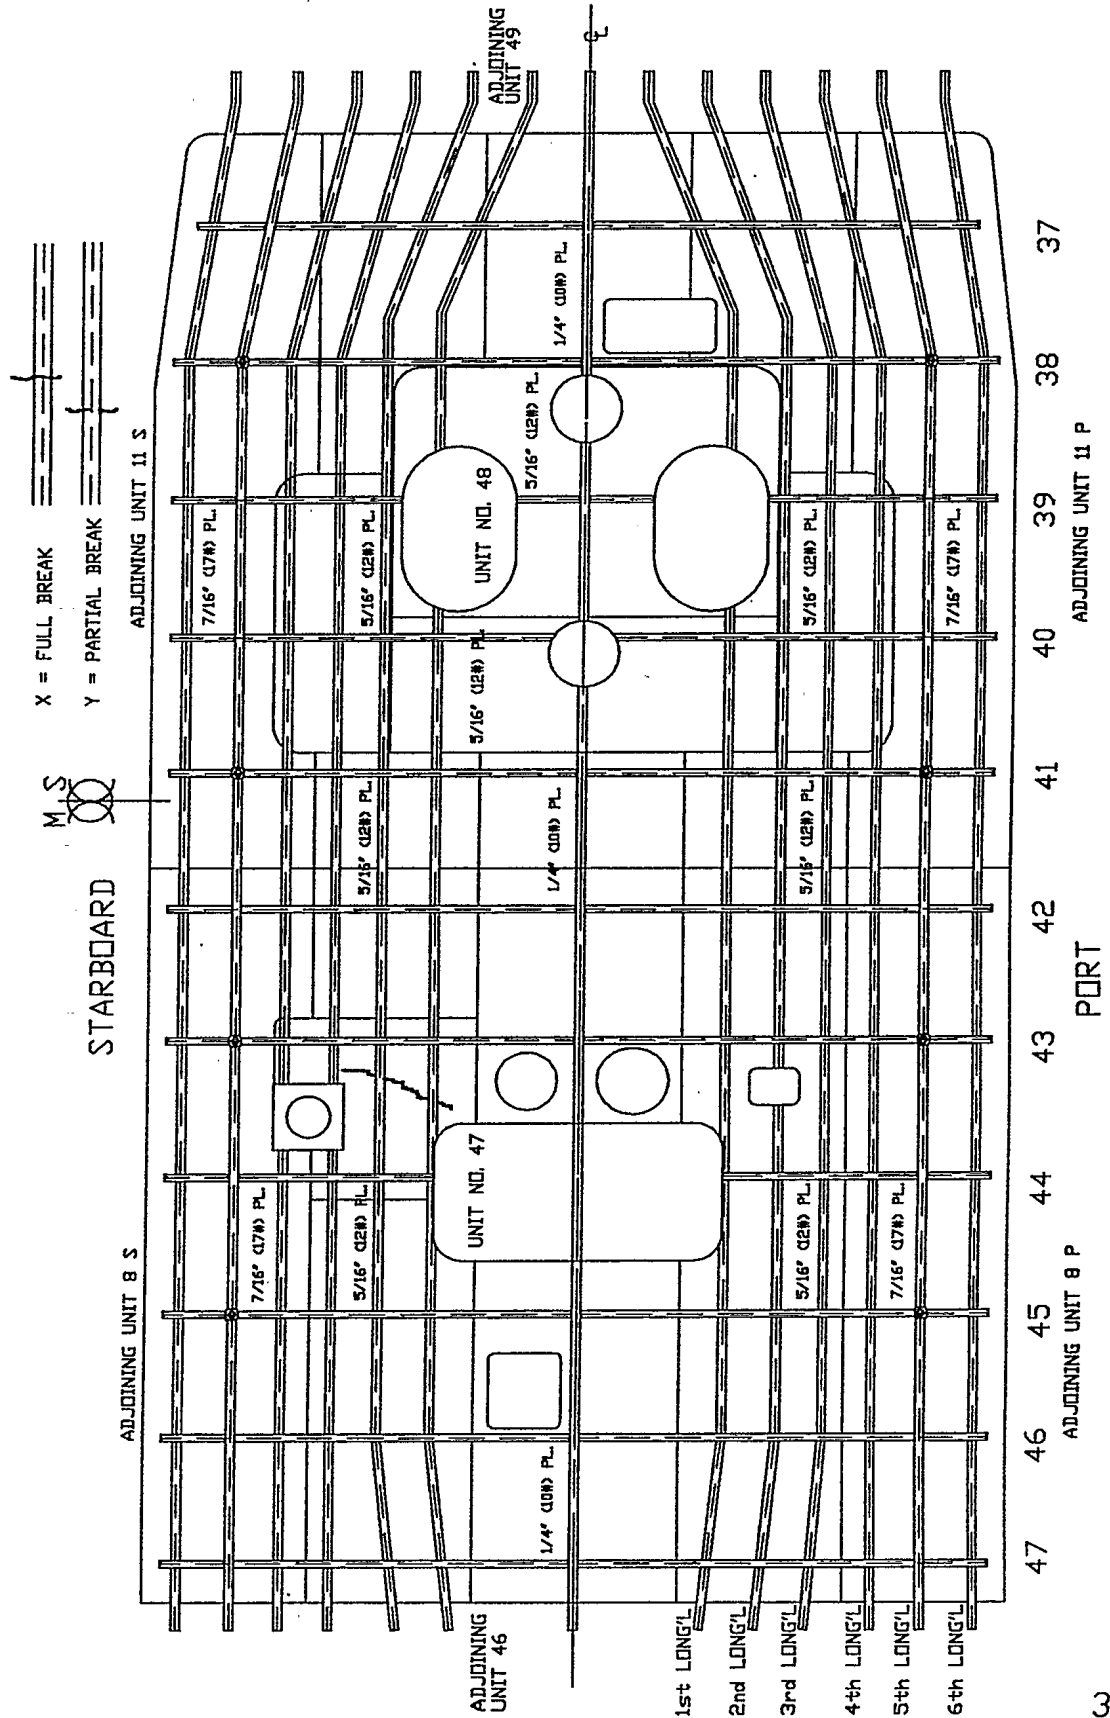
FIGURE 3-9
H.M.C.S. FRASER & SKEENA - 1976-77
PLAN VIEW BENEATH NO.1 DECK - FRAMES 37 TO 47

In 1976 HMCS SKEENA had some structural cracking in the vicinity of Frame 43, Starboard side under the after superstructure. Similar structural cracking occurred in HMCS FRASER in late 1976 or early 77 (Figure 3-9 refers). Both of these ships were repaired during their respective refits in 1976/77 by cropping out the defective area and replacing with a 17 lb. insert plate. These two ships were the first to show a significant structural failure in the midships area which could be interpreted as being a fatigue failure.

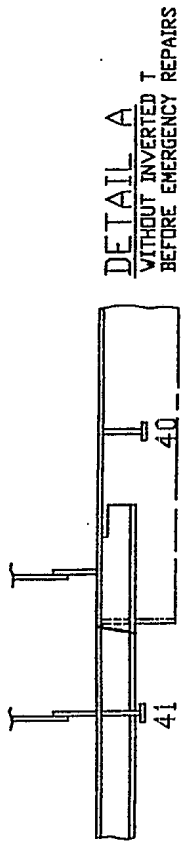
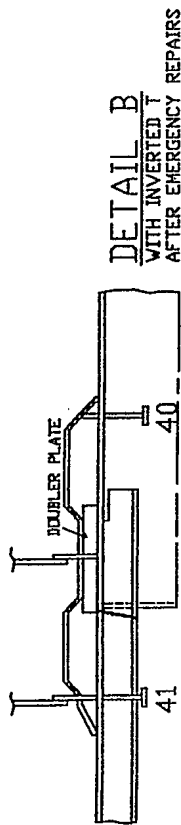
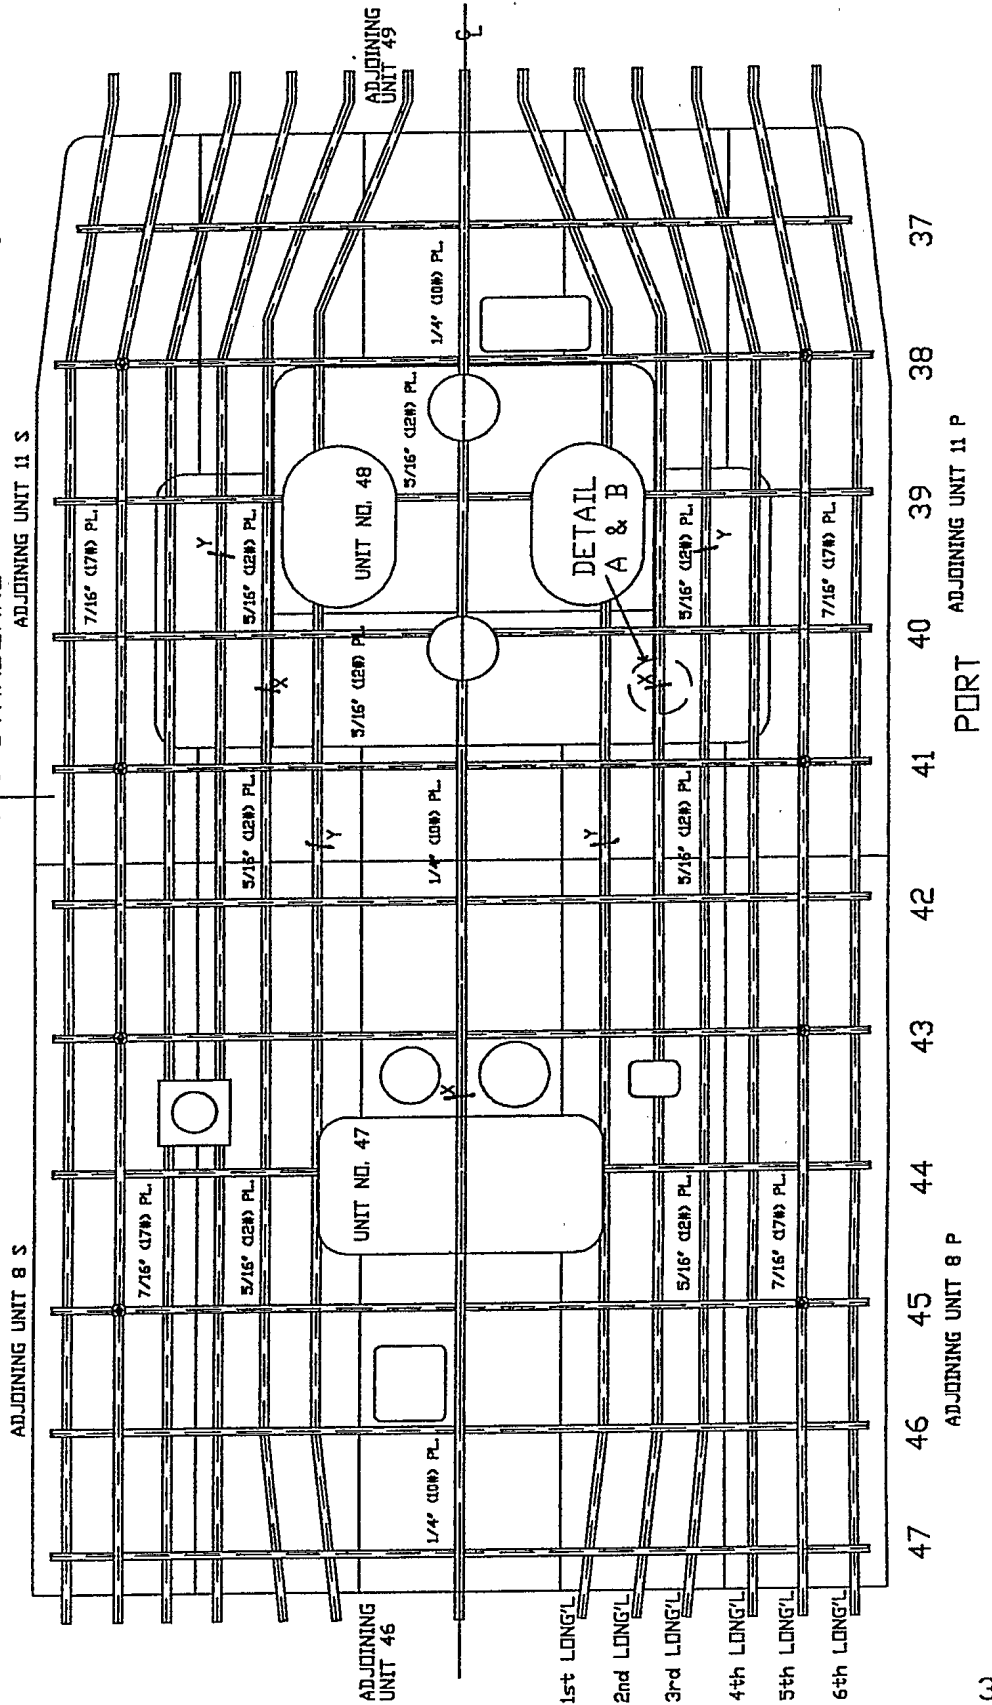
FIGURE 3-10
H.M.C.S. SAGUENAY - 1978
PLAN VIEW BENEATH NO.1 DECK - FRAMES 37 TO 47

HMCS SAGUENAY was given a check survey in early autumn of 1977 and was found to be free of any cracking in the midships portion of the ship. It is known the ship was called to an emergency rescue mission in the North Sea approximately November of 1977 in which the environmental conditions were Sea State 6 and the ship had full power on to execute the emergency. In the January to March time frame HMCS SAGUENAY served in the Fishery Patrol off the Grand Banks area in some rather significant sea conditions and very cold temperatures. In March 1978 HMCS SAGUENAY reported unusual structural noises and entered St. John's, Newfoundland harbour for an on-site inspection. Several longitudinals were fractured or in the progress of cracking. These included failure of longitudinal #2 Port and Starboard side in way of Frame 40; a crack had initiated in longitudinal #3 Starboard; partial cracking of longitudinal # 1 Port and Starboard; and centreline longitudinal crack in way of Frame 43 1/2. It is interesting to note that the line of the failures was approximately a "V" with the apex at the forward end of the Boiler Room air intakes branching outwards approximately 30° to the centreline to Frame 39 1/2 in way of longitudinal #3. An operational restriction was placed on the ship to sail from St. John's to Halifax in Sea State 4 or less.

Temporary emergency repairs were undertaken to ensure the safety of the ship for its deployment through the remaining operational commitments until August of 1978. Clearly, the emergency repairs were essential to ensure the ship's safety. Also it was clear that the proper interim repairs would take several weeks cutting into an operational commitment for Fisheries Patrols. The emergency repairs implemented in March 1978 included the installation of inverted "T"s above the line of #2 longitudinal Port and Starboard side spanning two frames either side of the #2 structural failures. The centreline longitudinal was repaired temporarily by "veeing out" and re-welding the area of the crack in the longitudinal member. The remaining known cracks were not touched at this time. Each time the ship returned to port between its Fisheries Patrols, the opportunity was taken to inspect the ship to ensure no progress in the area of structural failures.

In August 1978 the interim structural repairs were implemented by replacing a length of #2 longitudinal and modifying it to remove the structural discontinuity in the proximity of Frame 39. A section of the centreline longitudinal was also replaced just forward of the Boiler Intakes. All other repairs consisted of "veeing out" the defected area and rewelding the #3 and #1 longitudinals. No plate replacement was undertaken at this time. A minor crack was "veed out" and welded.

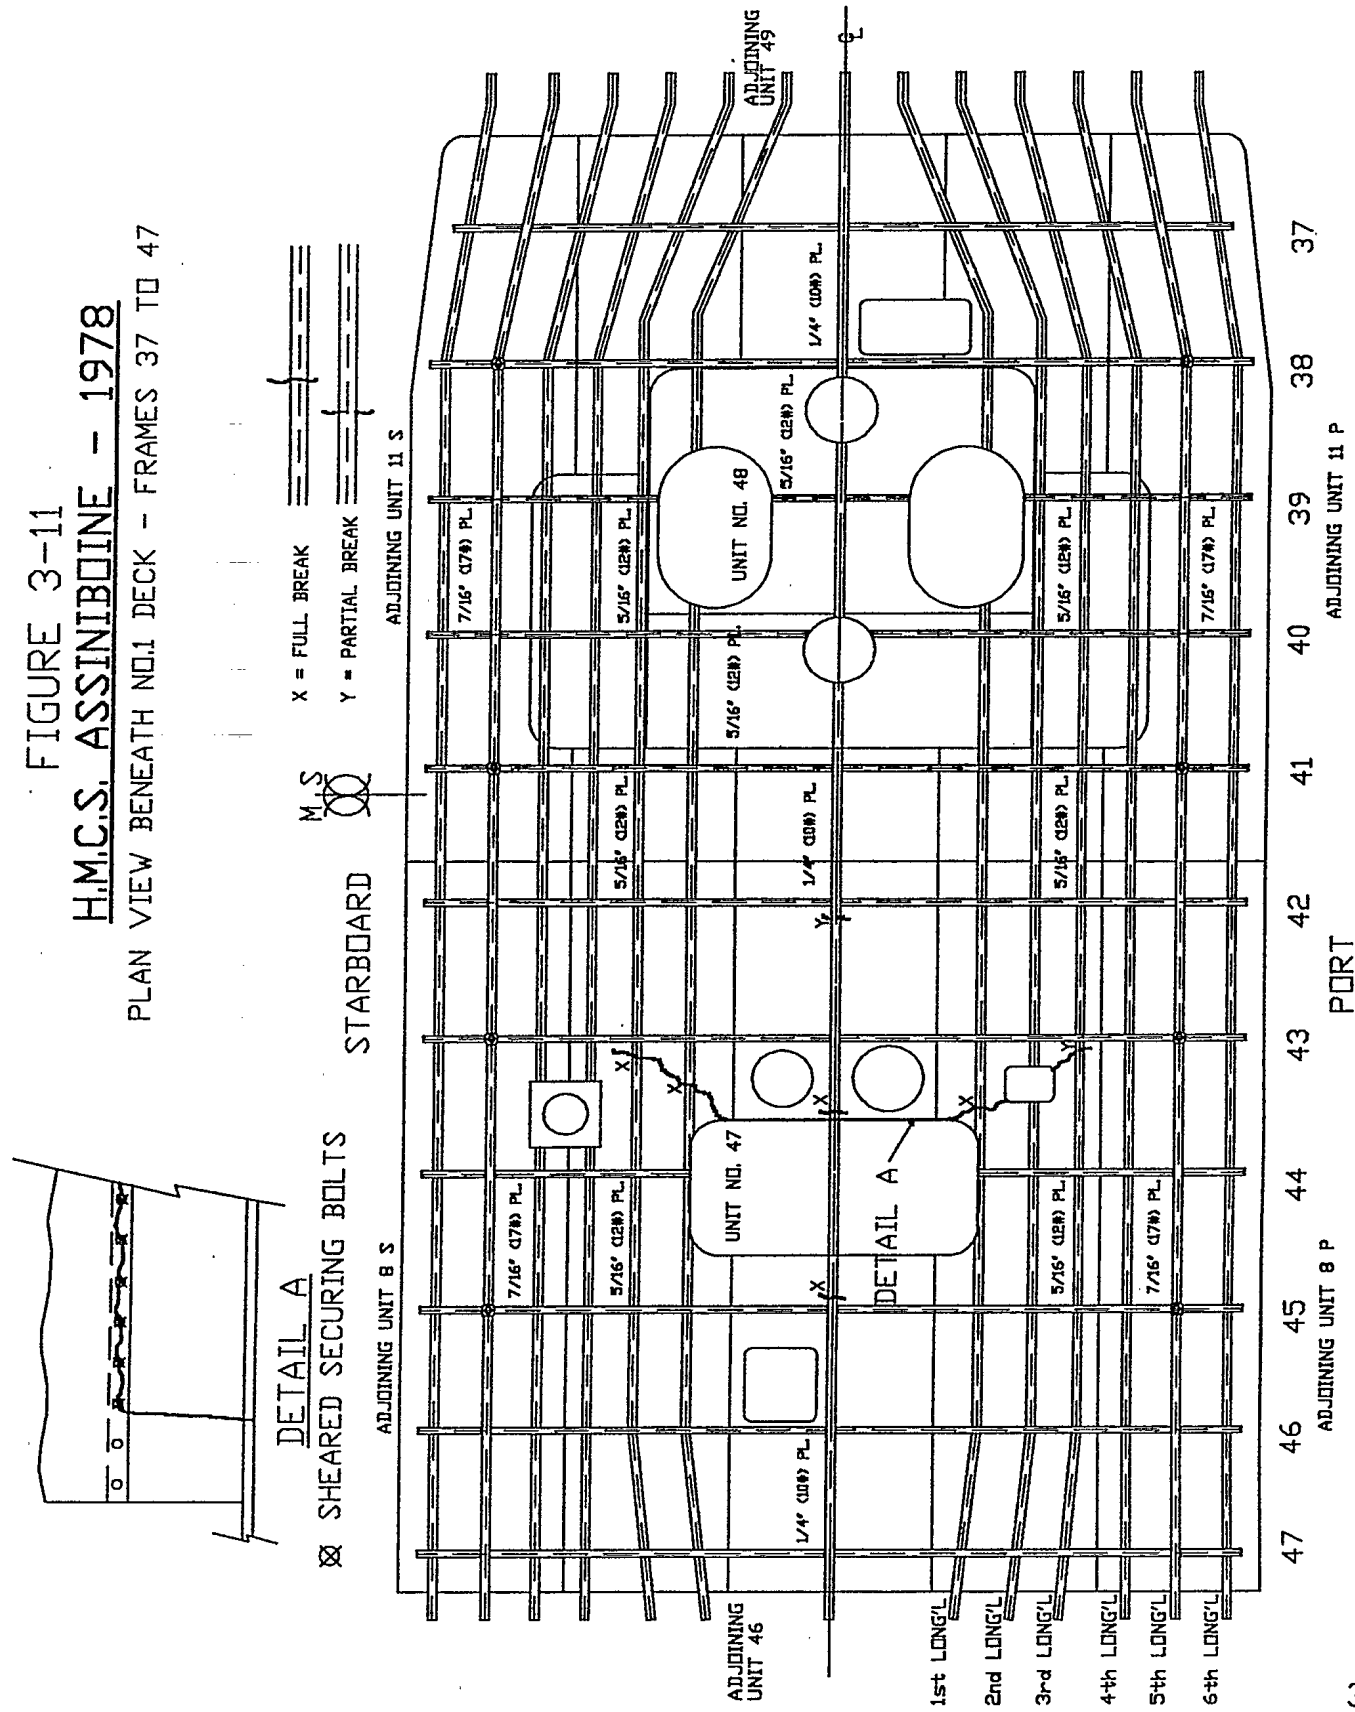
FIGURE 3-11 H.M.C.S. ASSINIBOINE - 1978

In the spring of 1978 HMCS ASSINIBOINE reported taking on water in the proximity of the Galley ventilation trunk, Port side, Frame 42. Upon inspection it was discovered that there was a continuous crack through the #1 Deck plating and the longitudinals from #3 longitudinal Port, across the Galley exhaust, #1 longitudinal Port, up the Boiler Intakes coaming, shearing all rivets in the bimetallic connection, down the coaming into the deck, across #1 and #2 longitudinals and was progressing towards #3 longitudinal. The centreline longitudinal was fractured in three locations in the proximity of Frame 43 1/2 just forward of the Boiler Intake in way of Frame 42 and just forward of Frame 45. It is significant that this ship had a continuous crack in #1 Deck midships from outboard of #3 longitudinal Port to just inboard of #3 Starboard. This is over half the width of the ship. The ship was removed from operational programs until such time as full interim repairs could be implemented. Extensive examinations of the area immediately forward and aft of the identified crack in No. 1 Deck area was undertaken to ensure there were no further failures occurring. It was this inspection procedure that discovered the centreline longitudinal failure near Frame 42. Interim repairs undertaken included a replacement of the centreline longitudinal from Frame 41, to and including, 45 1/2. A short section of #1 longitudinal Port and Starboard side was also replaced and an insert plate was installed in the proximity of the cracked area.

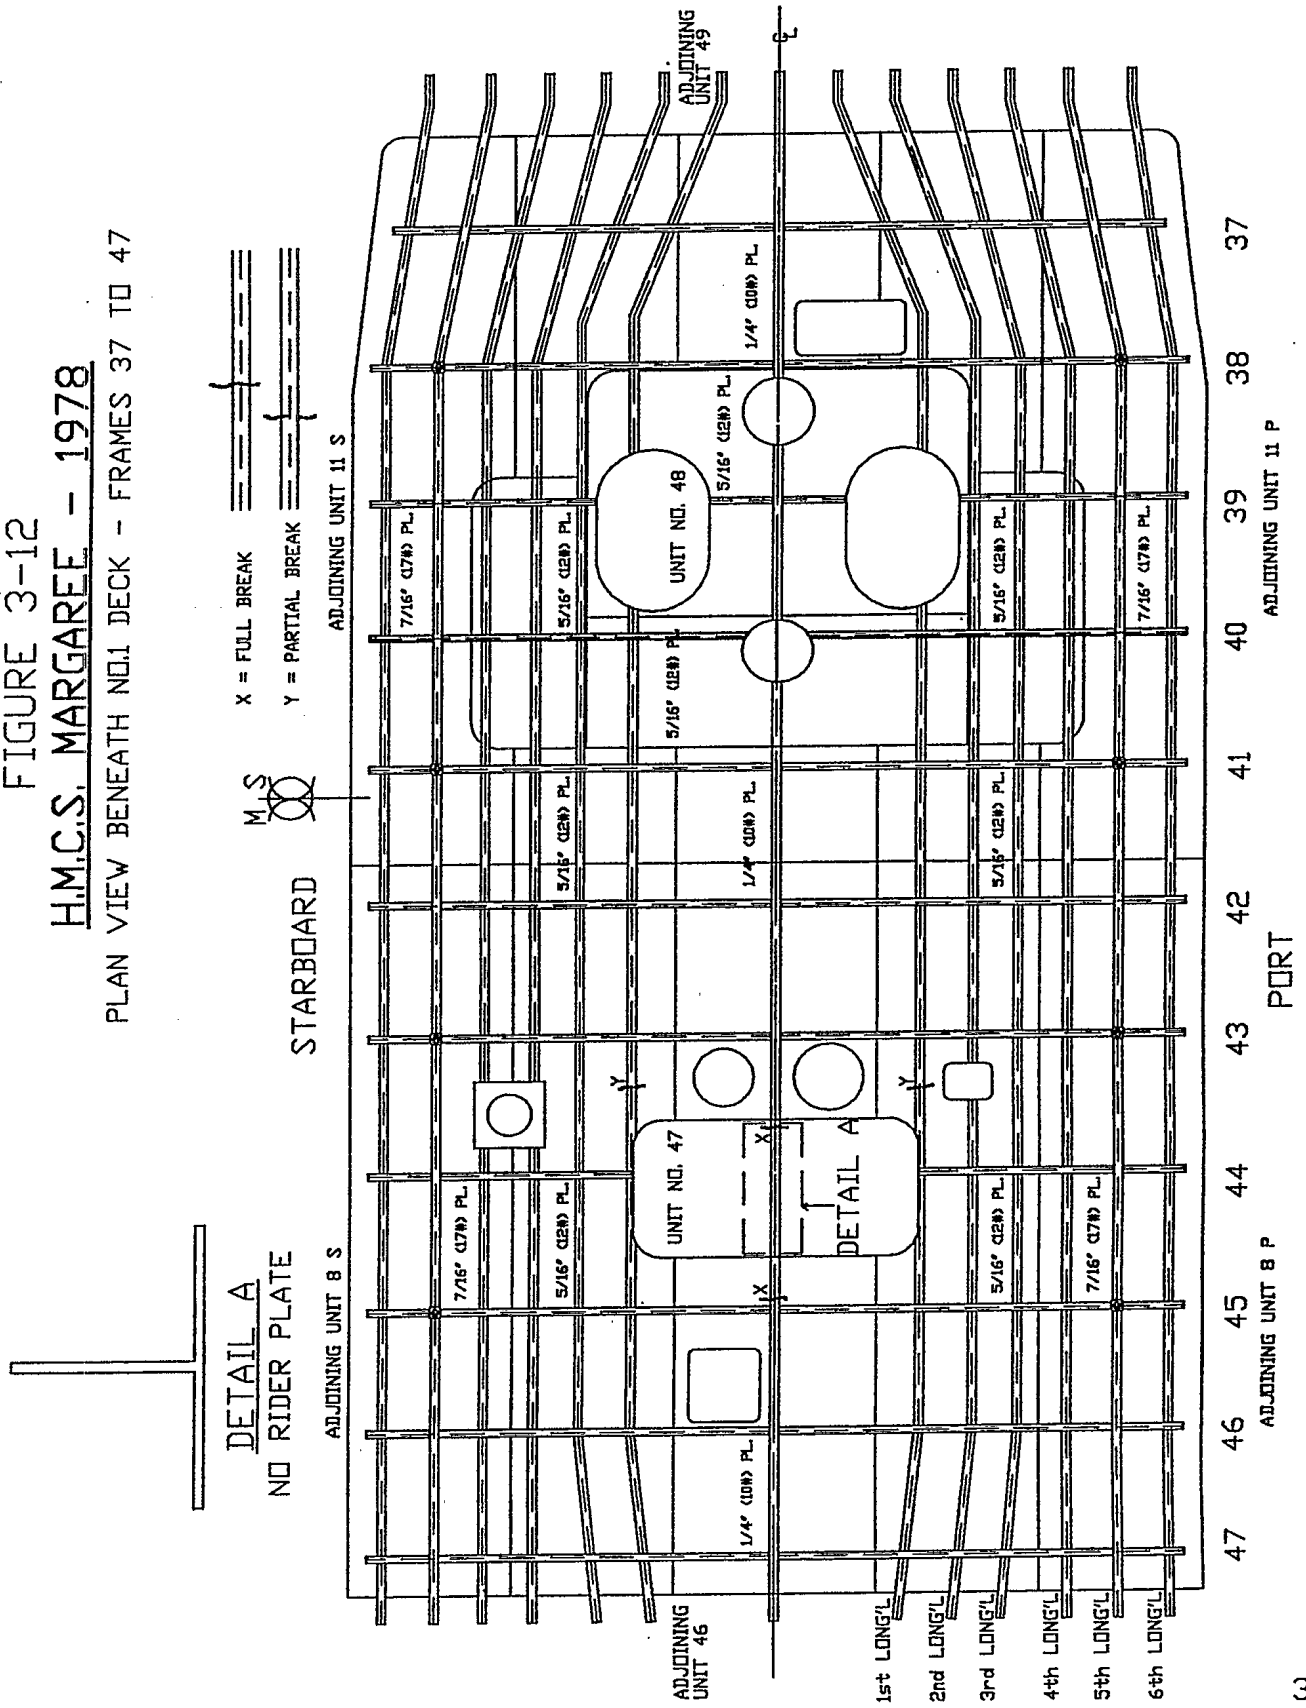
FIGURE 3-12
H.M.C.S. MARGAREE - 1978
PLAN VIEW BENEATH NO.1 DECK - FRAMES 37 TO 47

In the late summer of 1978 HMCS MARGAREE had structural failures of the centreline longitudinal in two locations, forward of Frame 45 and in the proximity of Frame 43. Cracking of the numbers 1 and 2 longitudinals was in progress and deck plate cracking had initiated between Frame 42 and 45. None of the cracks seemed to be in a specific pattern nor were they indicating that they were about to progress as a continuous crack across the ship. Of particular interest is the details of the centreline longitudinal passing through the Boiler Room inlets. The centreline longitudinal on all other ships of the Class was fitted with a "T" and rider plate configuration with flange top and bottom. In the case of MARGAREE it was a "T" with no rider plate on top.

The interim repair for this ship included replacement of the centreline longitudinal from approximately Frame 42 to Frame 45 1/2, with the section 43 1/2 to 45 being now an "H" section. A short section of #2 longitudinal Starboard was replaced in the proximity of Frames 42 to 43 and a small insert plate was installed in this general area. All other detected cracks were "veed out" and welded without replacement of the section or the plating involved.

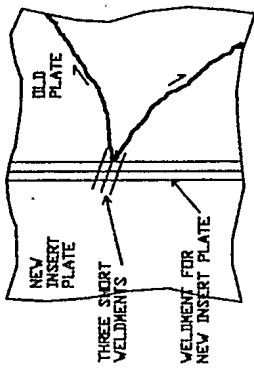
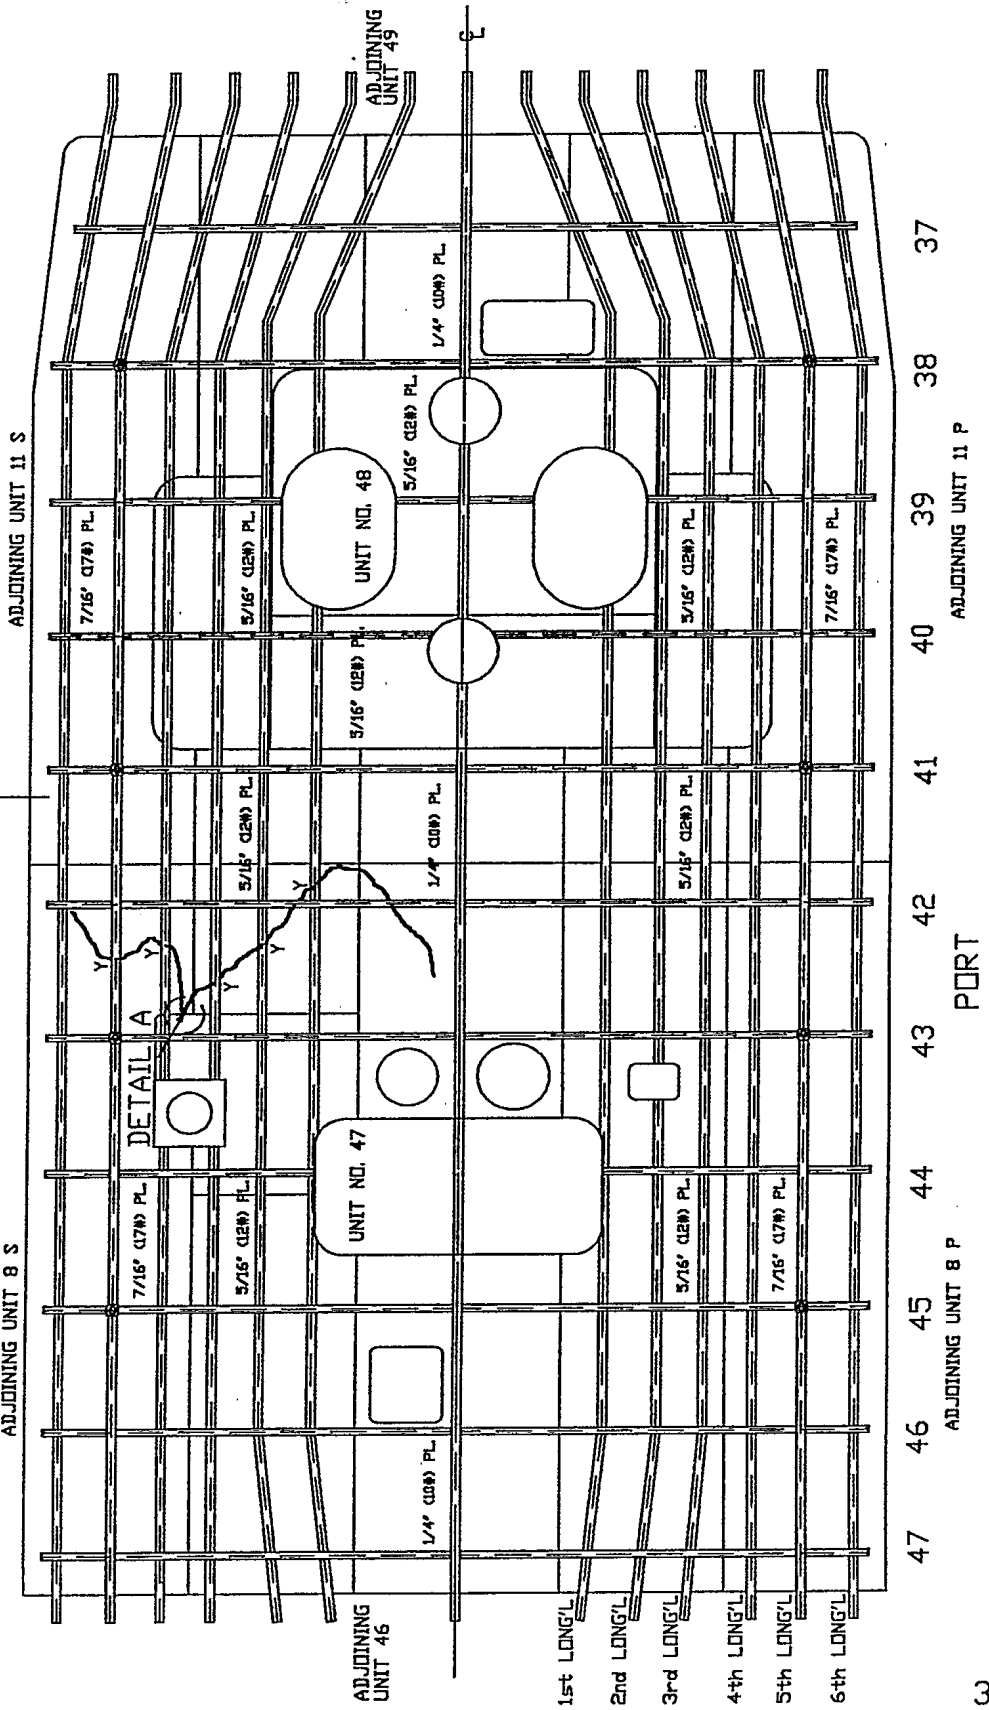
FIGURE 3-13 H.M.C.S. FRASER - 1979

Subsequent to the interim repairs identified above at 3.4.3, an instantaneous fracture occurred forward of the Boiler Room emergency escape hatch on the boundary of the new insert plate and old plate weldment. The point of initiation of this fracture was at the weldment of the insert where 3 beads of weldment were positioned diagonally across the insert weldment. The reasons for these three beads of weldment are unknown but could be related to a holding bracket for the insert plate positioning. The fracture occurred off the coast of Halifax in a Sea State 4 stern quartering sea. The ship reported an "odd" wave hitting them at the time of fracture. The fracture had radiated out in two directions in a random, irregular pattern, one inboard and one outboard from the point of inception. The total length of the crack was about 20 feet. The noise created was heard throughout the ship and because of the weather conditions at the time, water immediately started to enter the ship through the fracture crack. The ship returned to Halifax Harbour as soon as possible thereafterwards for an evaluation and appropriate repairs.

The inspection of the area indicated that a fracture had occurred and the inception was, as indicated above, at the very point of the intersection of the short beads across the insert weldment. A beautiful chevron pattern on the plate edge was quite obvious. The plate had some distortion (buckling) characteristics and the fracture crack had opened up a fraction of an inch. The total length of the fracture occurred in both directions through the existing old plate. By inspection it appeared that the locale of the fracture initiation was a source of high stress concentration, probably in the form of residual stresses which, when combined with longitudinal stresses and the stresses due to the racking of the ship in the stern quartering sea, was sufficient to cause the stress levels to be beyond the ultimate strength of the structural members. The interim repair in this case was to replace a substantial panel of plating with slightly heavier plate from just inboard the centreline to outboard of #3 longitudinal, between Frame 43 and Frame 41. The longitudinals affected by the fracture were "veed out" and rewelded except #2. A section of the #2 longitudinal was replaced between Frame 41 1/2 to aft of 43.

POINT OF INCEPTION
OF FRACTURE
ADJOINING UNIT 8 S
