DEPARTMENT OF NATIONAL DEFENCE (NAVAL SERVICE)

FILE NUMBER 1810-254/9 NS 1057-154-6	SUBJECT CANADIAN NAVAL SHIPS & AUXILIARIES. H.M.C.S. "HAMILTON" DESTROYER. COLLISIONS.	Cross References
Vol. No. 117		
From 3/3/42.		
To

SUBJECT: COLLISION WITH C.P.R. PIER, DIGBY, N.S.

REPORT OF COLLISION OR GROUNDING

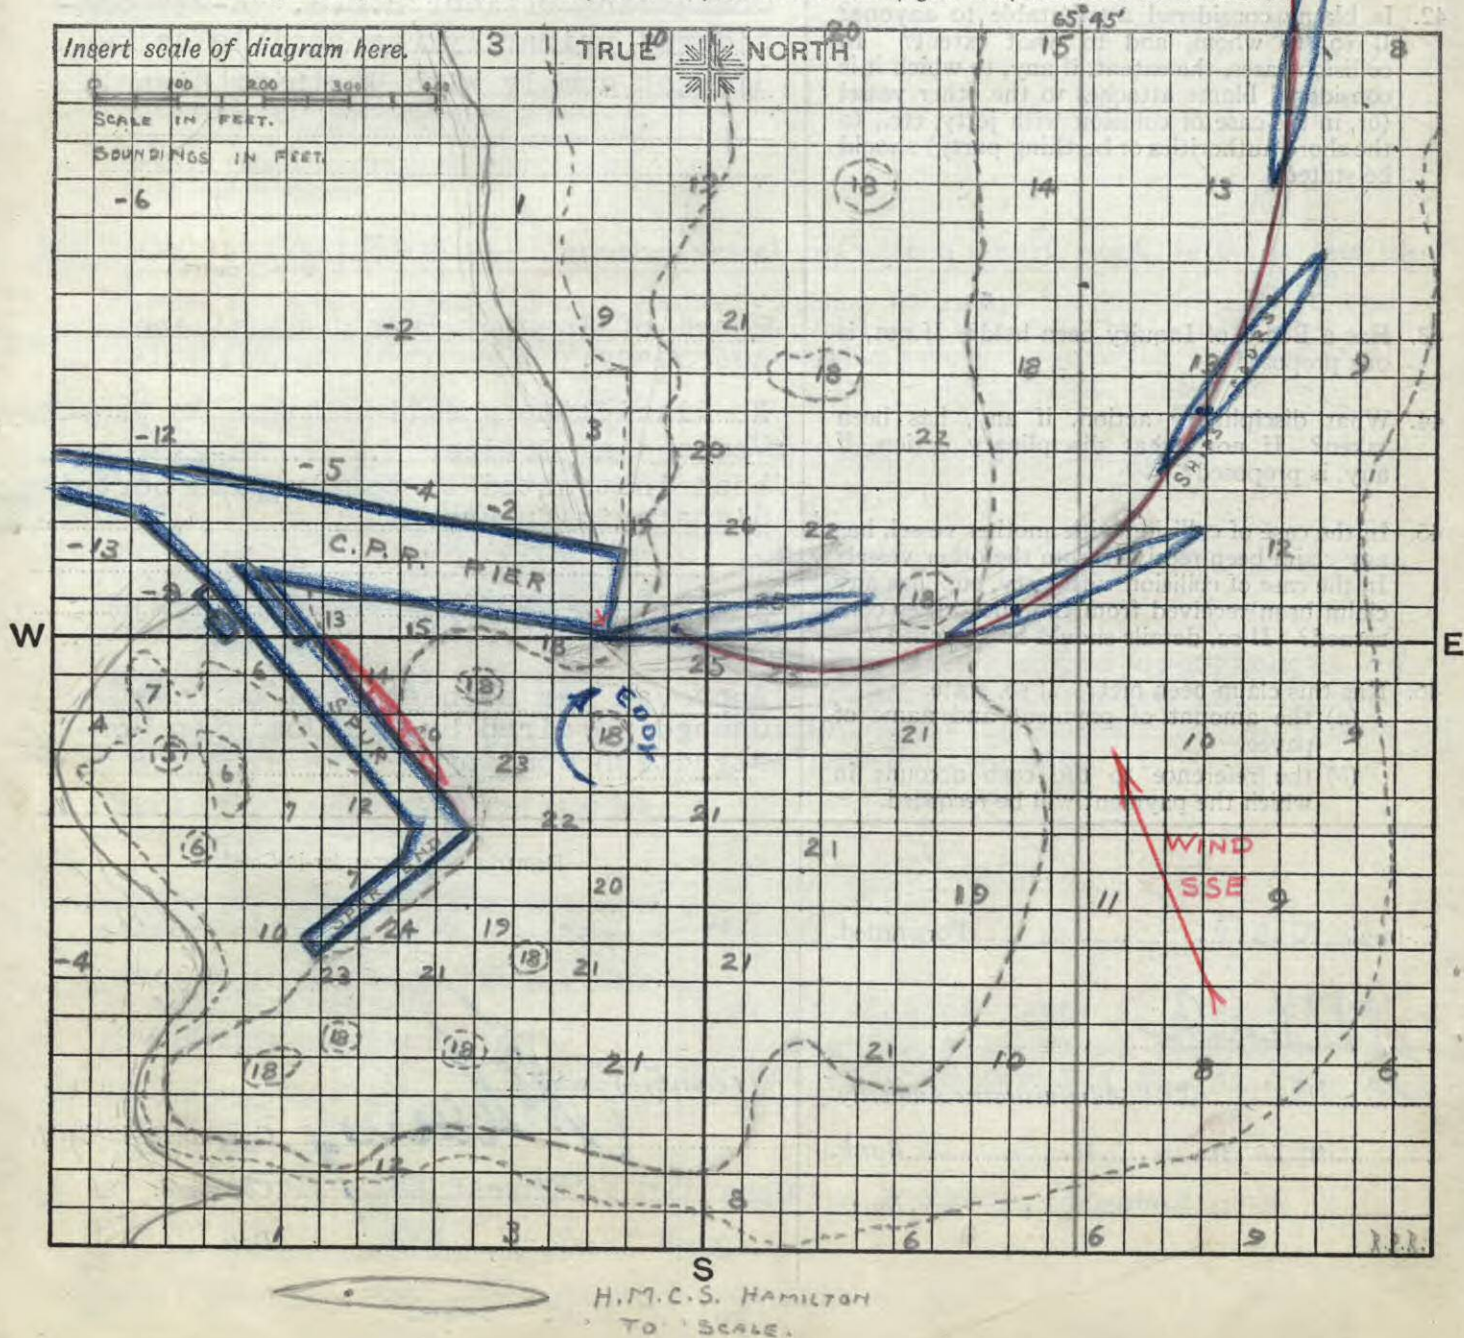
This diagram has been amended. The original curve showed the approximate position of ship's compass platform. It is difficult to construct a curve which will show the track of a ship which is (1) under helm; (2) engines stopped; (3) engines reversed; (4) in shallow water; (5) with the tidal current on her stern; (6) with an eddy under her bow; (7) abeam wind; (8) slight list to port.

Diagram now shows as accurately as scale permits position in which H.M.C.S. "HAMILTON" struck the jetty; that is - she struck the jetty with the starboard side of her stem, the ship still having some headway.

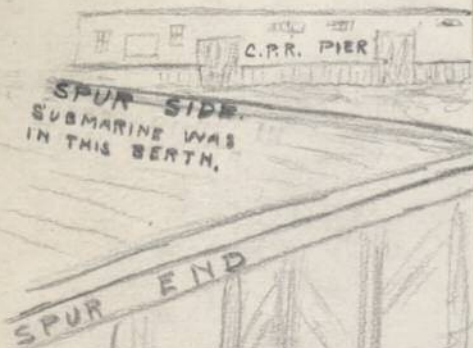
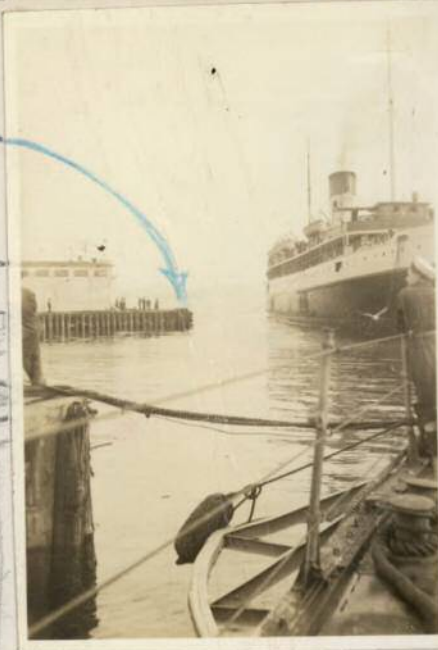
5. It is understood that Pier itself was not damaged, but "sponson" which is used as a sort of rubbing post for S.S. Princess Helene was damaged. Both C.P.R. Pier and Spur are in poor condition and need repair.

PHOTO OF S.S. PRINCESS HELENE
APPROACHING VEE.

H.M.C.S. HAMILTON
STRUCK THIS CORNER

Approval has been granted to have damage repaired by the Dominion Construction Company.

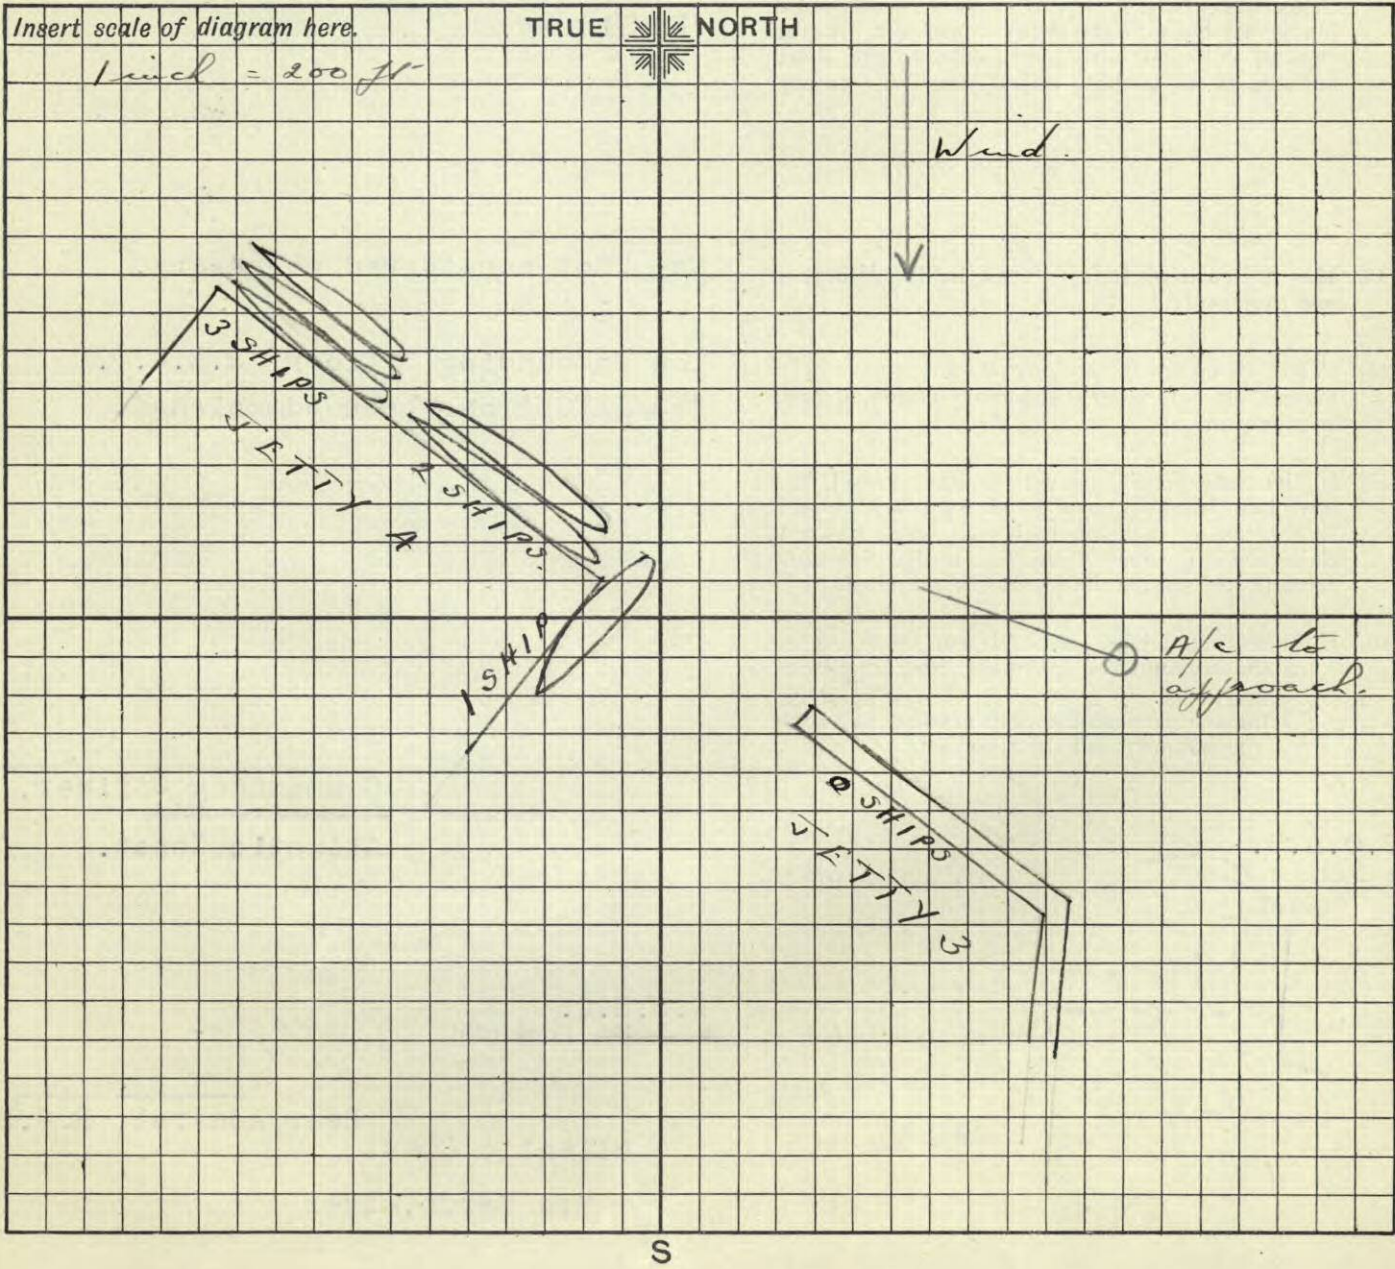
37) Minor damage only, sustained by.....
41) "St. Clair".
