DDH 205 CLASS STRUCTURAL INTEGRITY HISTORY 1951-1994

**DDH 205 CLASS
STRUCTURAL INTEGRITY HISTORY
1951-1994**

by D.J. Hussey¹, C.D. Roushorn¹, D.G. Smith², LCDR K.B. Holt³, Lt(N) K. Kirkov³

Presented at the Canadian Forces/Chief Research and Development Meeting
on "Naval Applications of Materials Technology", Halifax, May 1995.

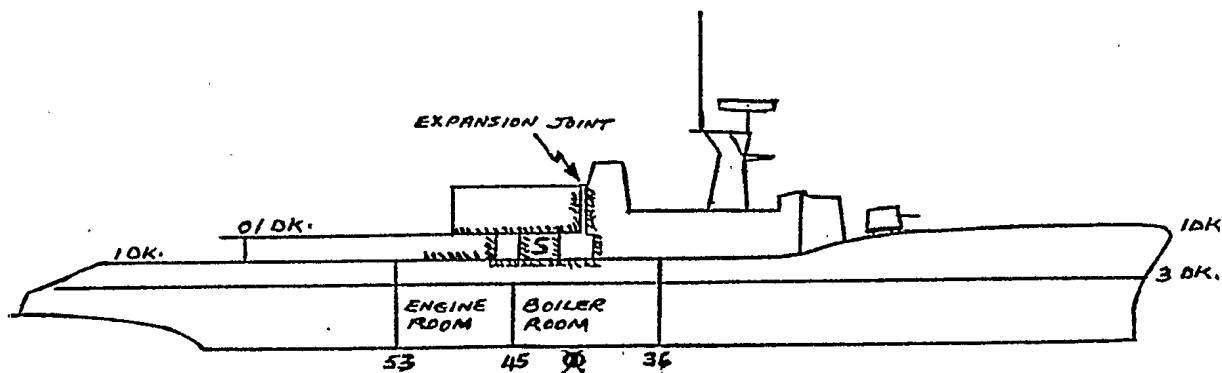
Figure 3-2

No major changes were made to #1 Deck midships region of the steel hull, Fr. 39-45 except that necessary to accommodate the twin funnel openings, port and starboard of the ship's centreline (as opposed to the single C.L. funnel of the DDE) to permit the nose of the helicopter to fit between the uptakes in the hangar. The outboard strake of plate at 1 Deck Fr. 39-45 was 17 lbs. (7/16 inch, 11mm, 17.85 lbs.) while the inboard plate was 12 lb. and the centreline strake was 10 lbs. (1/4 inch or over 6mm). It appears there was no appreciation of the large vertical loads which would be transmitted to the 1 Deck midships area from the large hangar (and parked helicopter) cantilevered from the flight deck, supported only by the structure surrounding the Boiler air intake(s), see Figure 3-2.

Rough Profile of a DDH 205/265 Class Destroyer
